# Replacement of disks, gaskets, bearings inspection and internal cleaning.

Every 2000 hours

# SLICK SHIFT assembly

# Bearing replacement. Disassembling

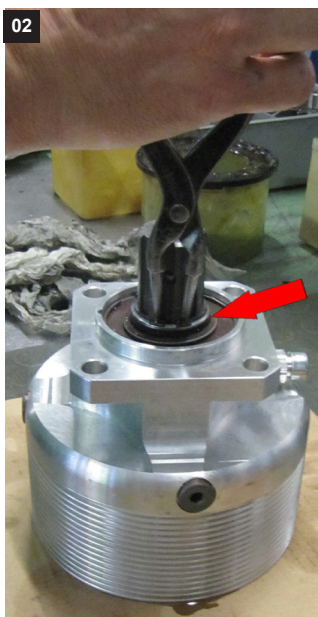
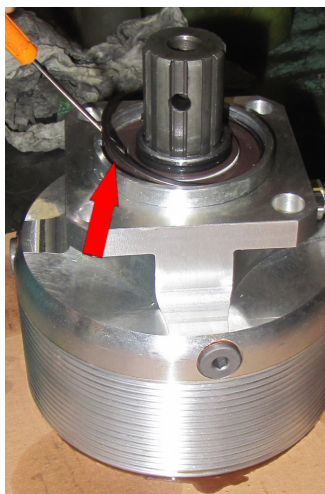
02

Remove indicated Seeger Ring on the shaft and elastic ring.

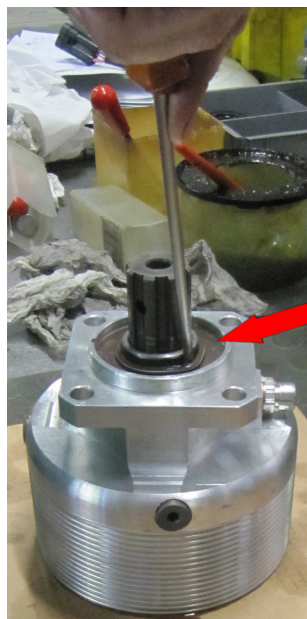
03

Remove the oil seal by means of a screwdriver. The oil seal must be replaced with a brand new one.

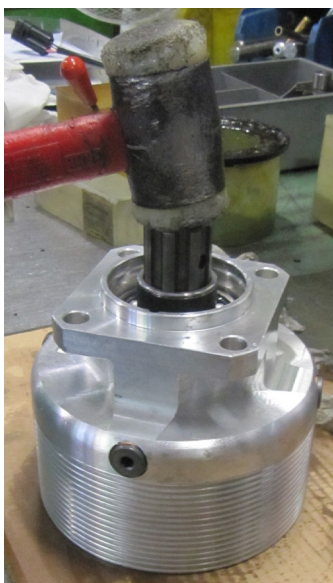
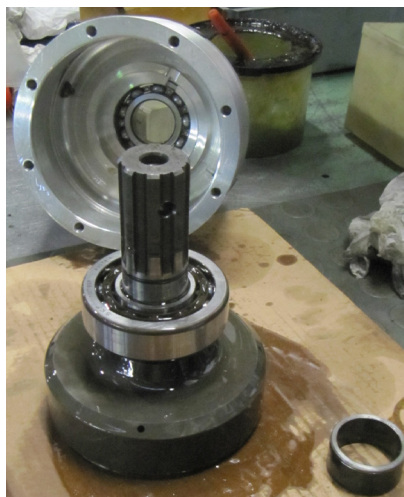
04

Hit the shaft with a plastic hammer until the shaft comes off from the bottom.

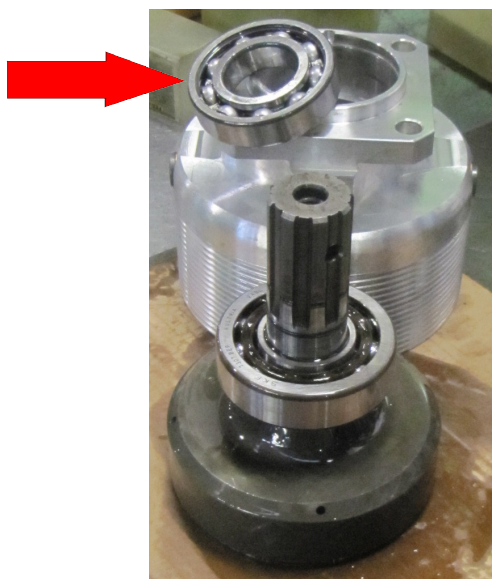
05

Remove indicated bearing and replace it.

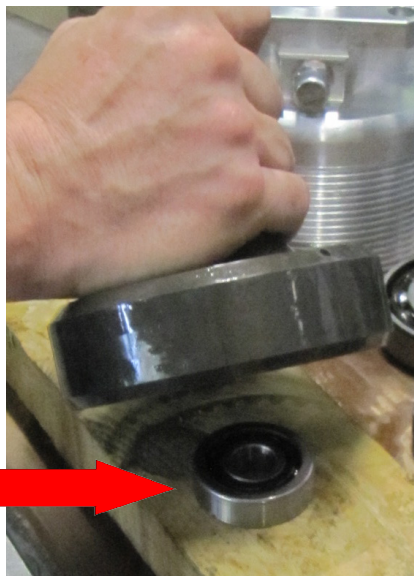
07

Hit the opposite side of the shaft on the wooden surface until the internal bearing comes off. Replace it.

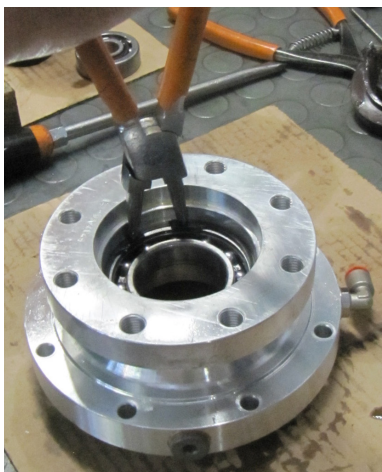
08

Take the other half SLICK SHIFT body, separated at point 01. Remove the Seeger ring from the hub and then the complete Hub Unit. Extract also the axial bearing and replace it.

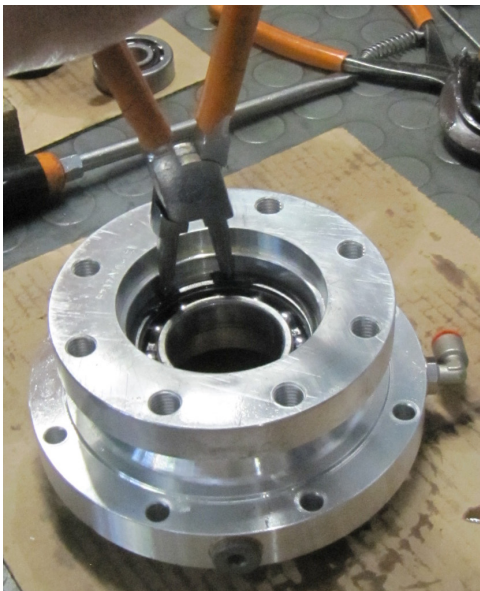
10

Rotate 180° the body, remove the Seeger ring which is "holding" the bearing.

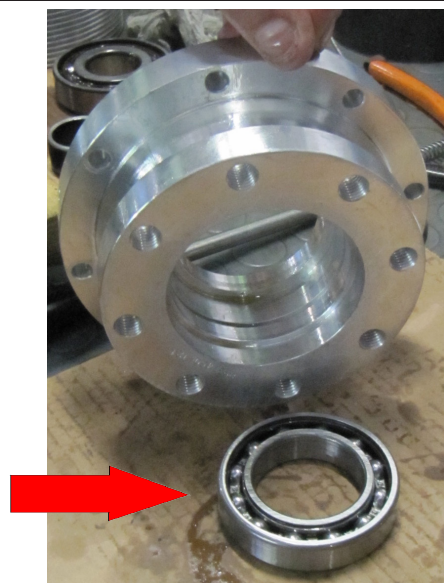
11

Extract the bearing and replace it.

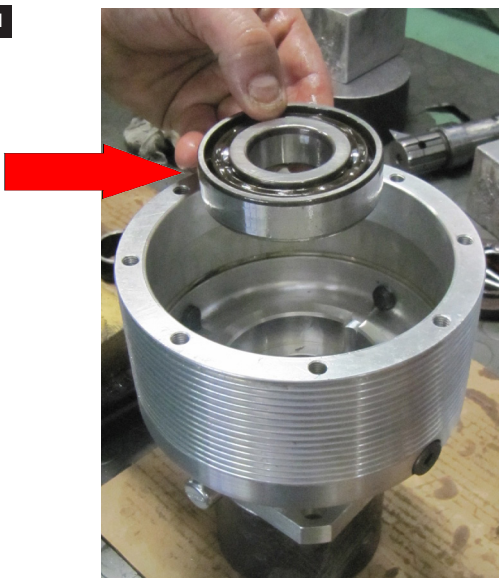
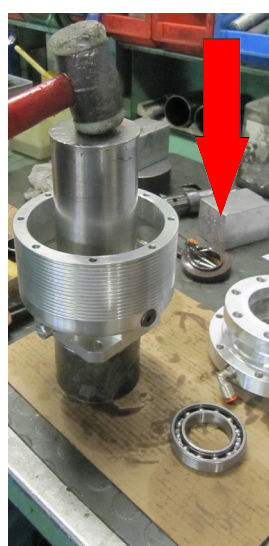
01

Insert the new bearing and push it in its seating.

**Bearing Kit  
code 10399020055.**

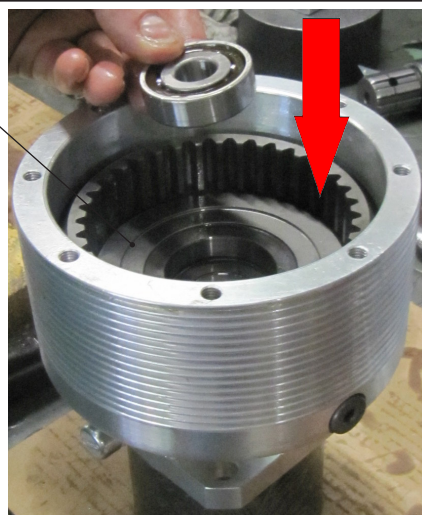
02

Place the shaft and then the new bearing on the bottom.

**ATTENTION!** Check that “reaction disk” indicated with “X” has remained in its original position, if not re-place it properly with the right orientation.

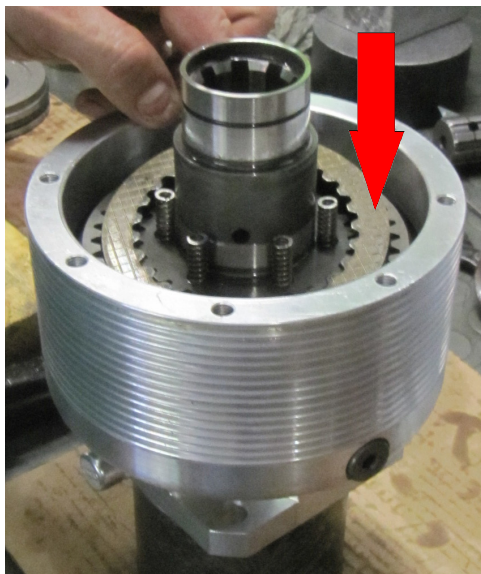
04

Insert alternatively and in sequence n.1 "friction disk" and n.1 "steel plate".

n° 8 friction disks.  
n° 7 steel plates.

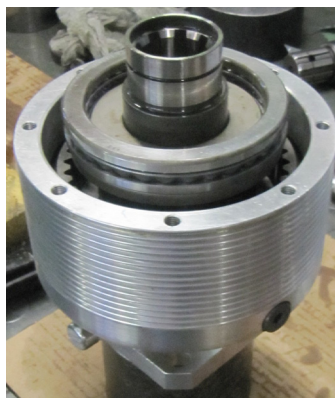
05

Insert in sequence the "pressure disk" (check correct mounting side) and the new axial bearing.

**Bearings Kit code 10399020055.**

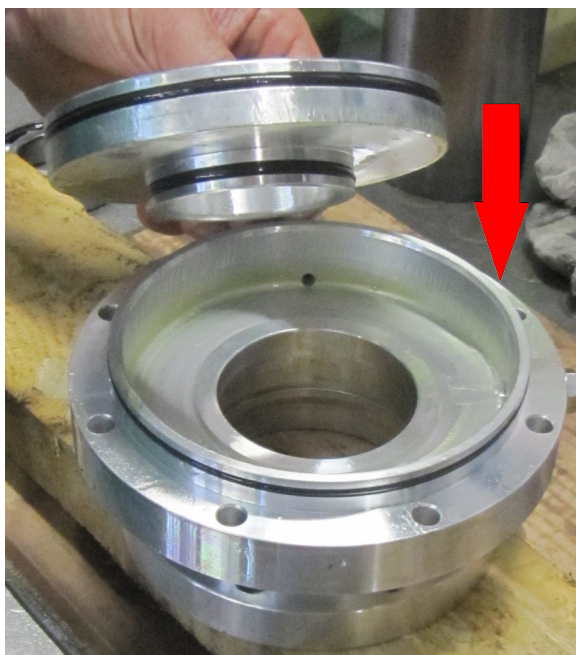
06

On the other half Slick Shift body, insert indicated piston as shown.

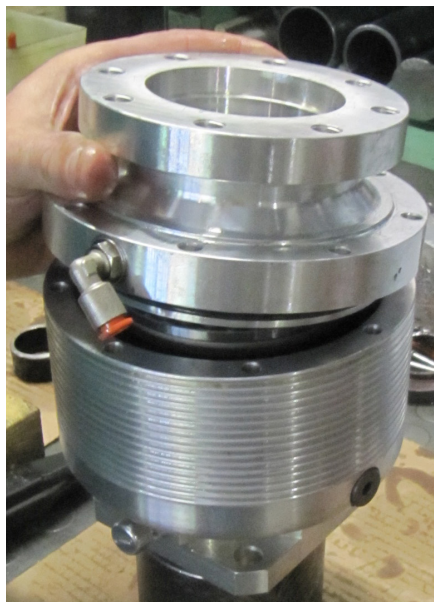
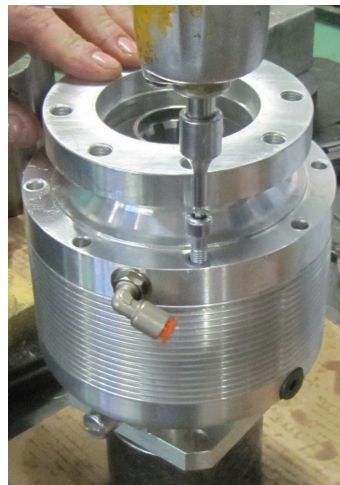
07

Couple the half body indicated in step n.6 with the other half body assembled before. Screw in the 8 screws with tightening torque = 25 Nm.

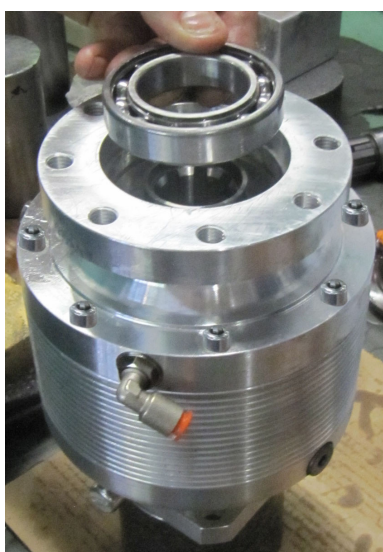
08

Place the new bearing and, in sequence, the Seeger ring on the hub and a new oil seal.  
**Seal Kit code 10399030053.**

**Bearing Kit code 10399020055.**

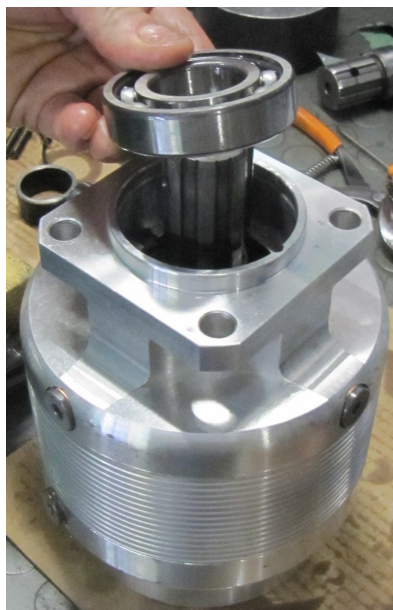
09

Rotate the Slick Shift and place the new bearing in its seating.

**Bearing Kit code 10399020055.**

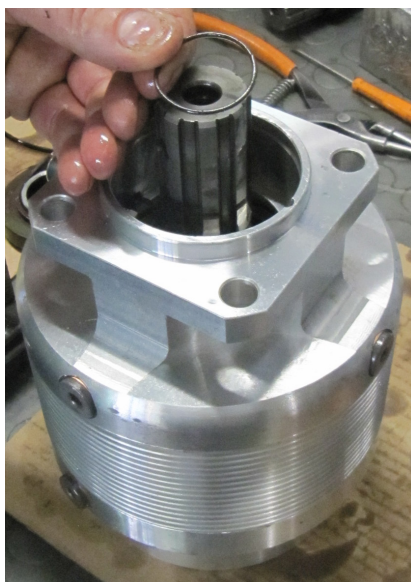
10

Place the new O-Ring on the shaft.

**Seal Kit code 10399030053.**

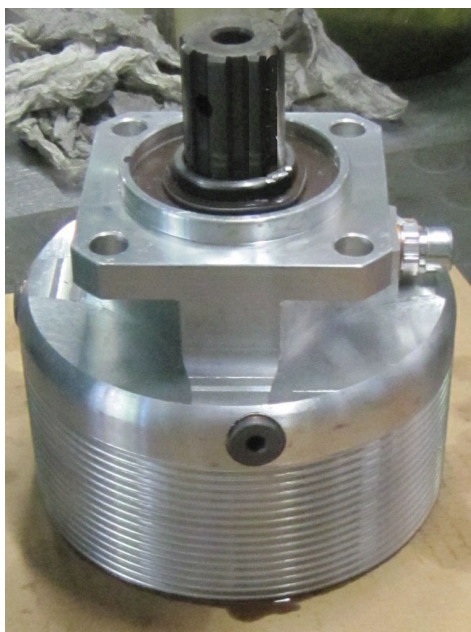
12

Place both bushing and oil seal on the shaft. Slightly hammer them alternative (make sure they don't separate in this phase) until they are properly in their seat.
